AJS/Matchless Heavyweight Rear Hub, speedometer side assembly sequence

Assembly of the Speedometer side of the rear hub of a '56 G-11. This was done with assistance of the Jampot Article from January 1998 titled "The Heavyweight Rear Hub" by C.G., edited by Chris Read as well as moral support from Mark Siebert and Pete "the cheap". Since I had difficulties in getting mine assembled correctly, I thought I'd take the time to make a web page out of it for others to share.

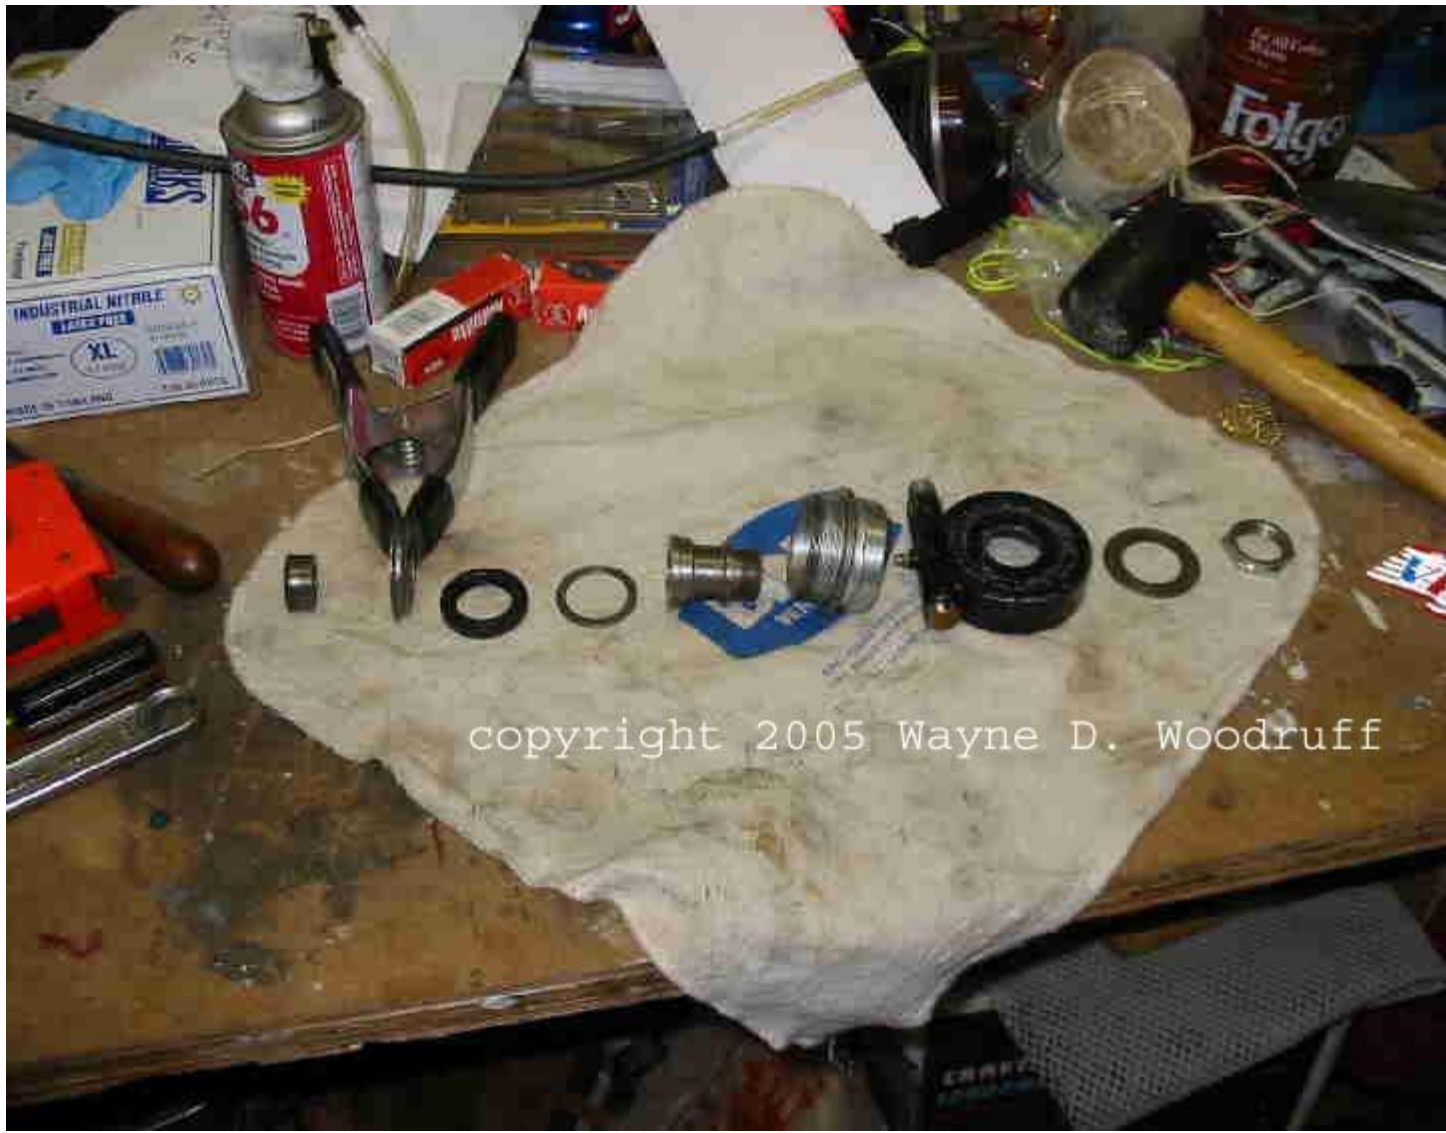
Fig 1: All parts laid out in the proper sequence and proper orientation. Pay particular attention to the orientation of the seal cup (2nd part from the left). The "wide" side faces **AWAY** from the seal!

Matchless part numbers from left to right:

- 021608 - spacer, on rear wheel solid spindle, for oil seal
- 018094 - Cup, for rear hub bearing oil-seal
- 014387 - Oil-seal, for rear hub bearing
- 021585 - Ring, retaining, rear hub bearing oil seal (small)
- 021594 - Spacer on rear wheel spindle for speedo gear box
- 021583 - Ring, adjusting, for rear hub and 021584 - Nut, lock, for rear hub bearing adjusting ring shown together

- speedo drive
- ??? washer for speedo drive
- 021593 - Nut, locking, speedometer gearbox

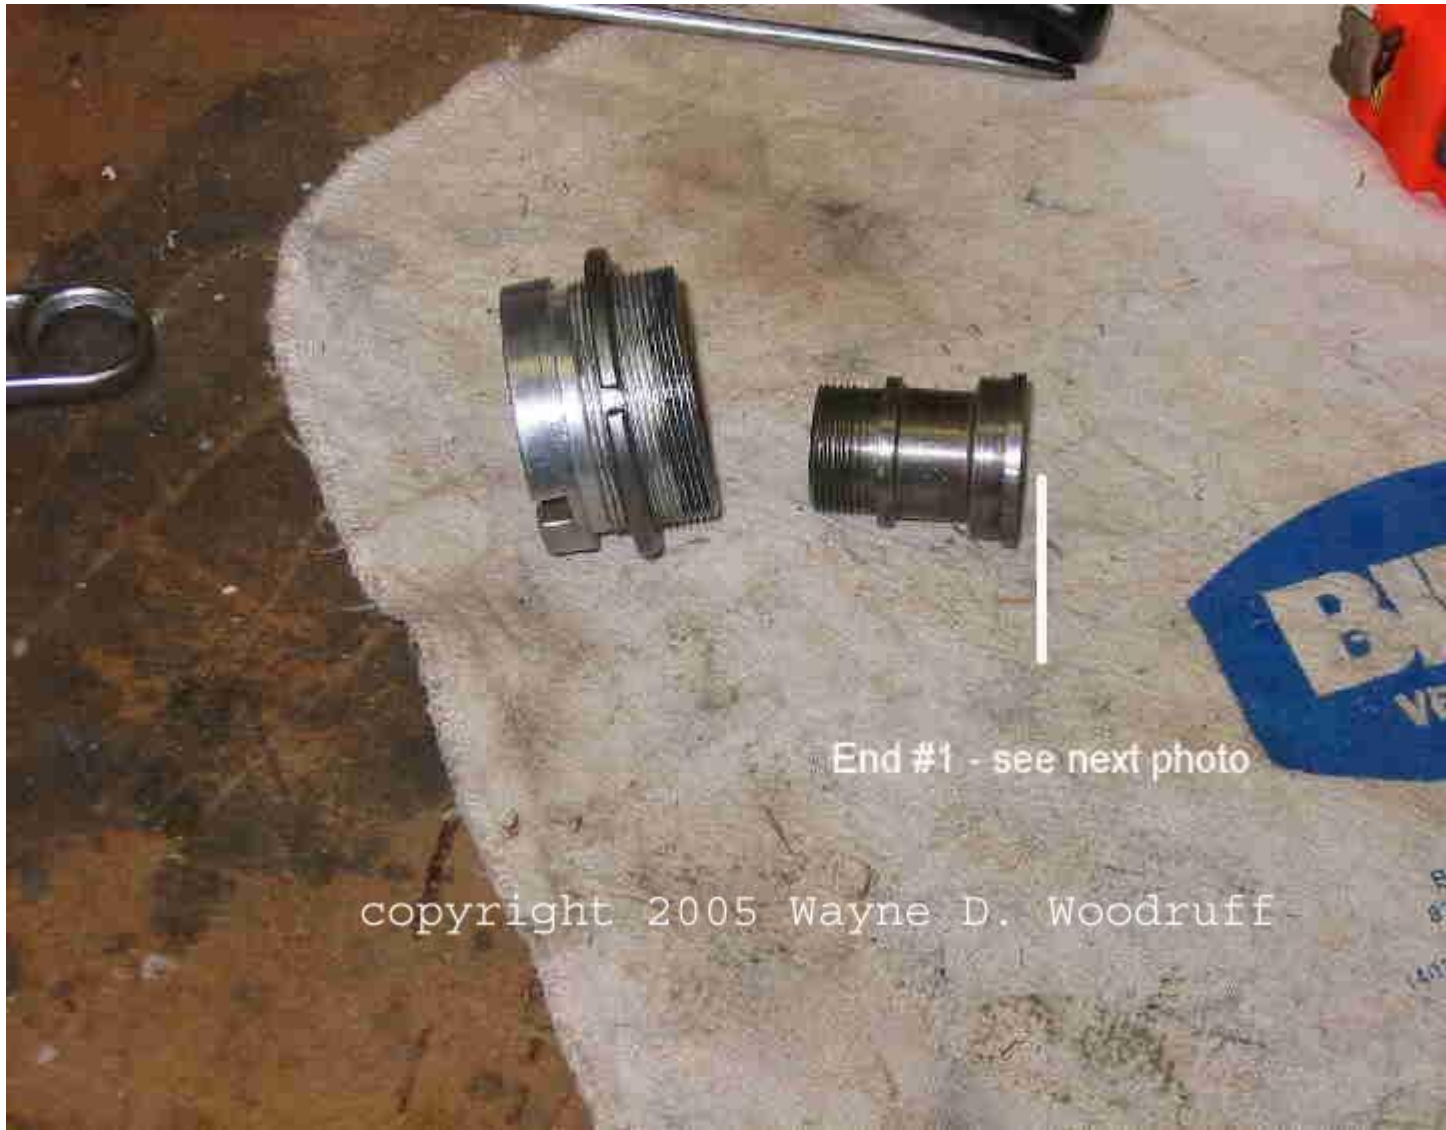
Fig 2: The threaded axle the speedo drive attaches to as about to be inserted in the retaining ring

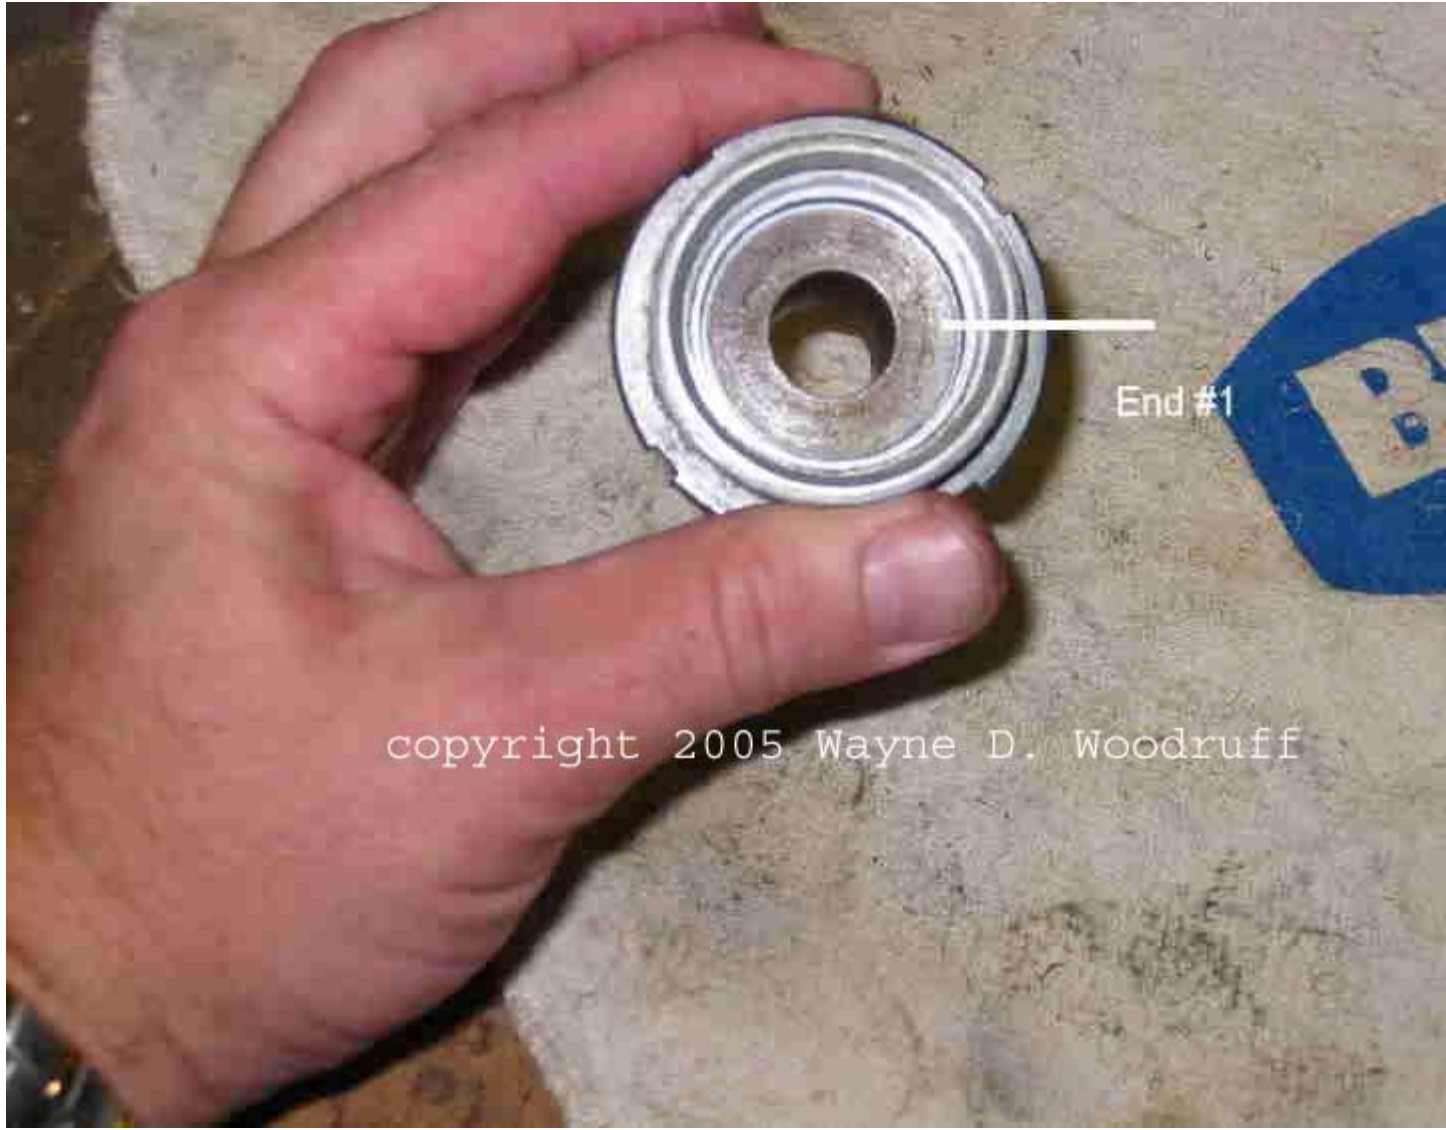
Fig 3: End view of Fig 2. The threaded axle now rests in the seat

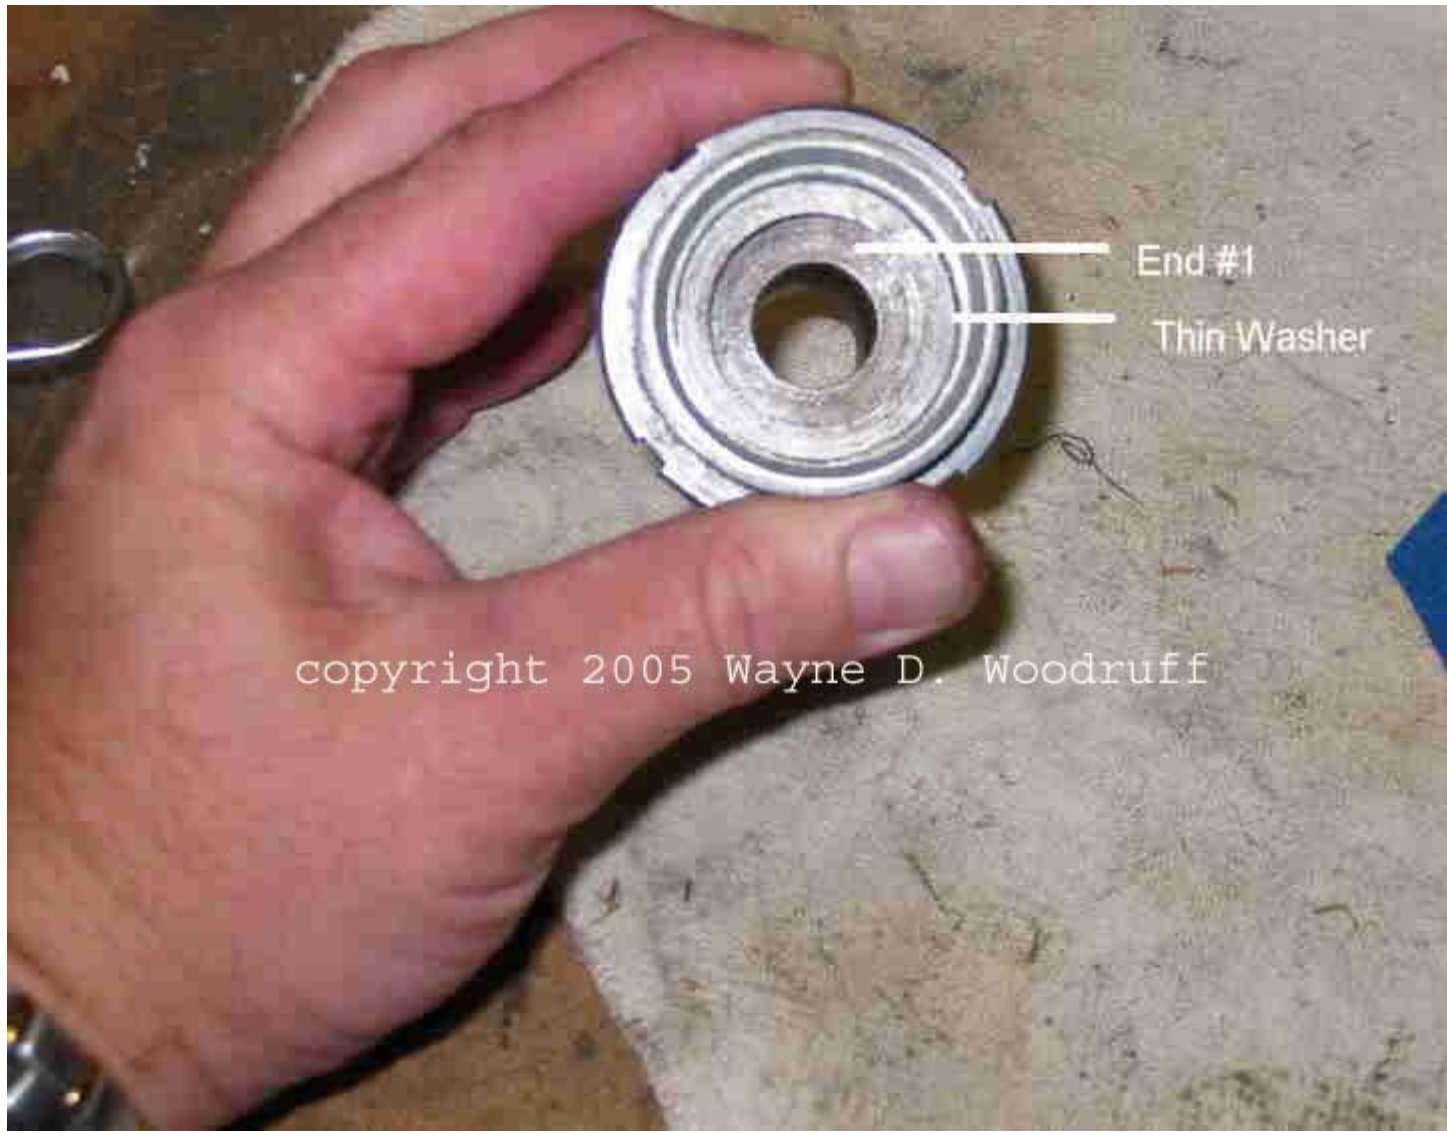
Fig 4: The thin washer (4th from left in 1st photo) now in place

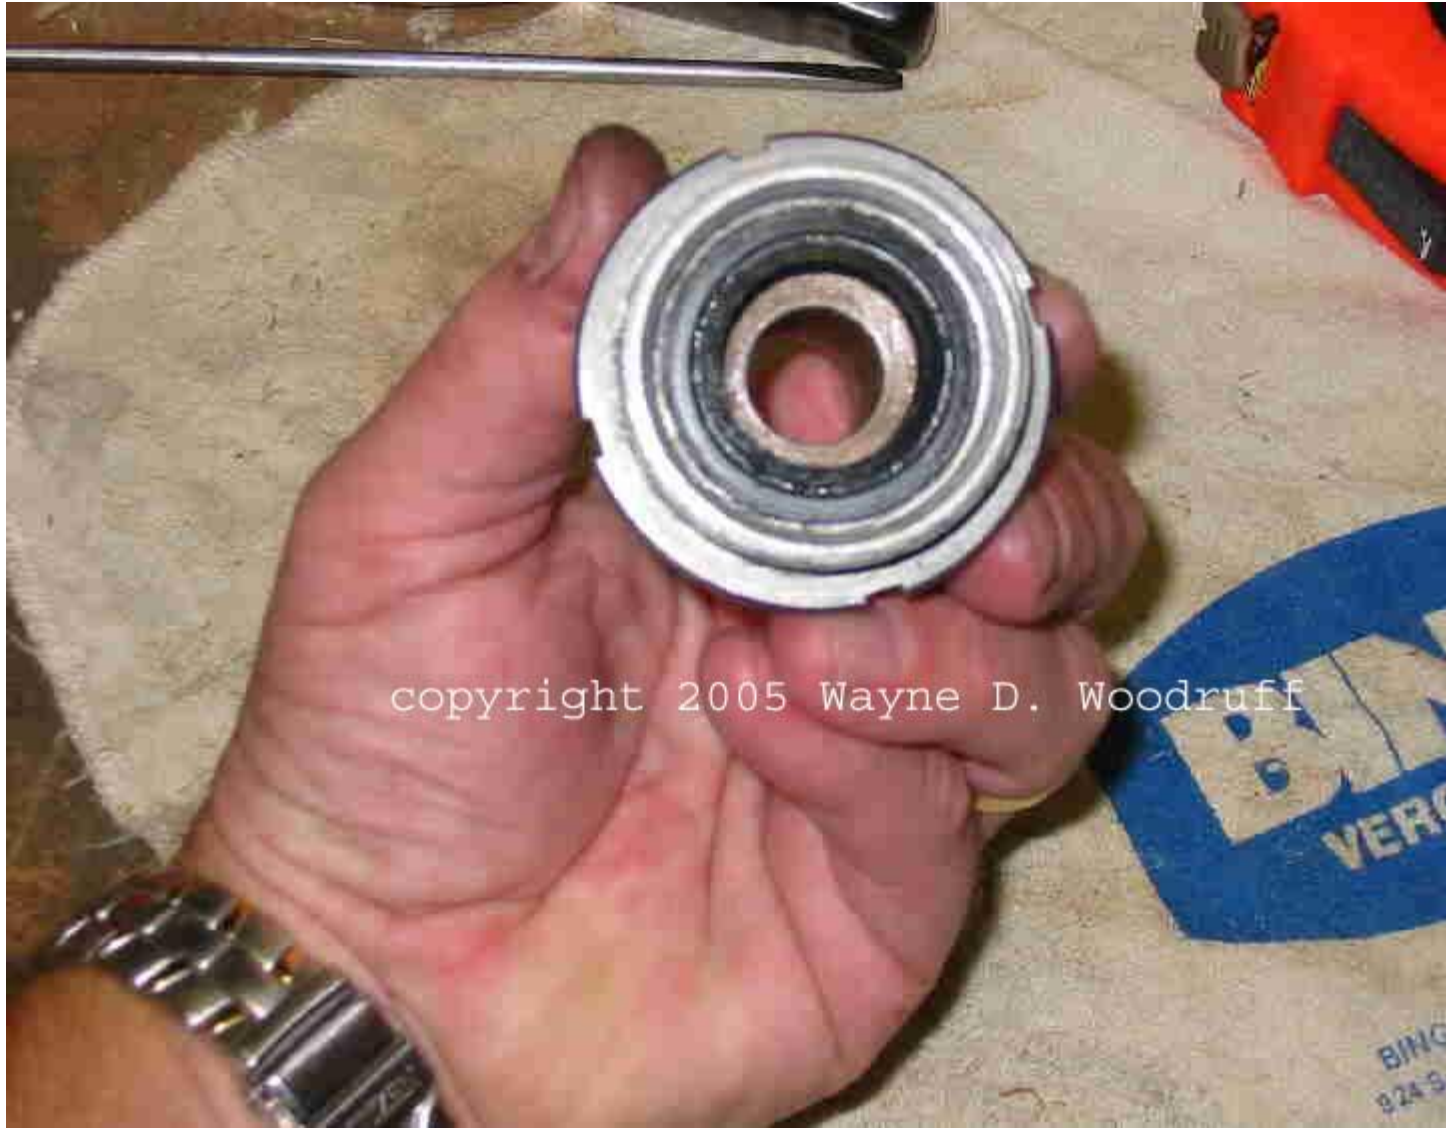
Fig 5: Rubber (or felt) seal now in place. You must work this to fit within the opening in the housing.

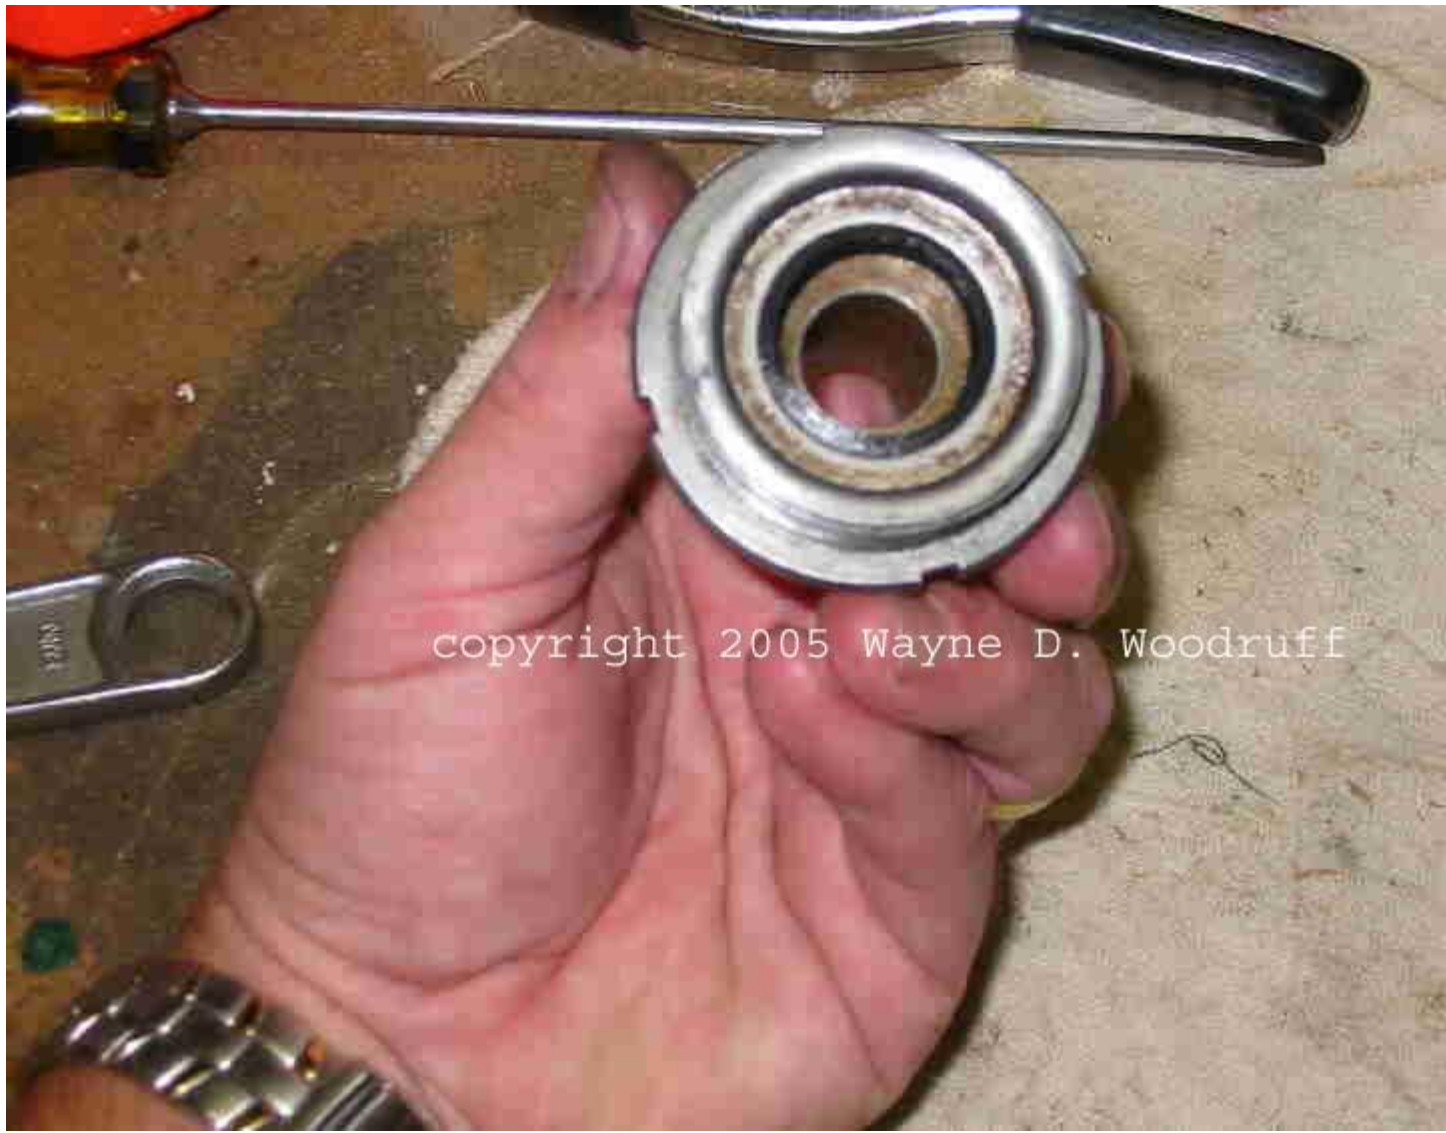
Fig 6: Cup in place (2nd part from left in photo #1). Again, note the orientation of the cup. **This orientation is critical!!** The "narrow" side faces the oil seal.

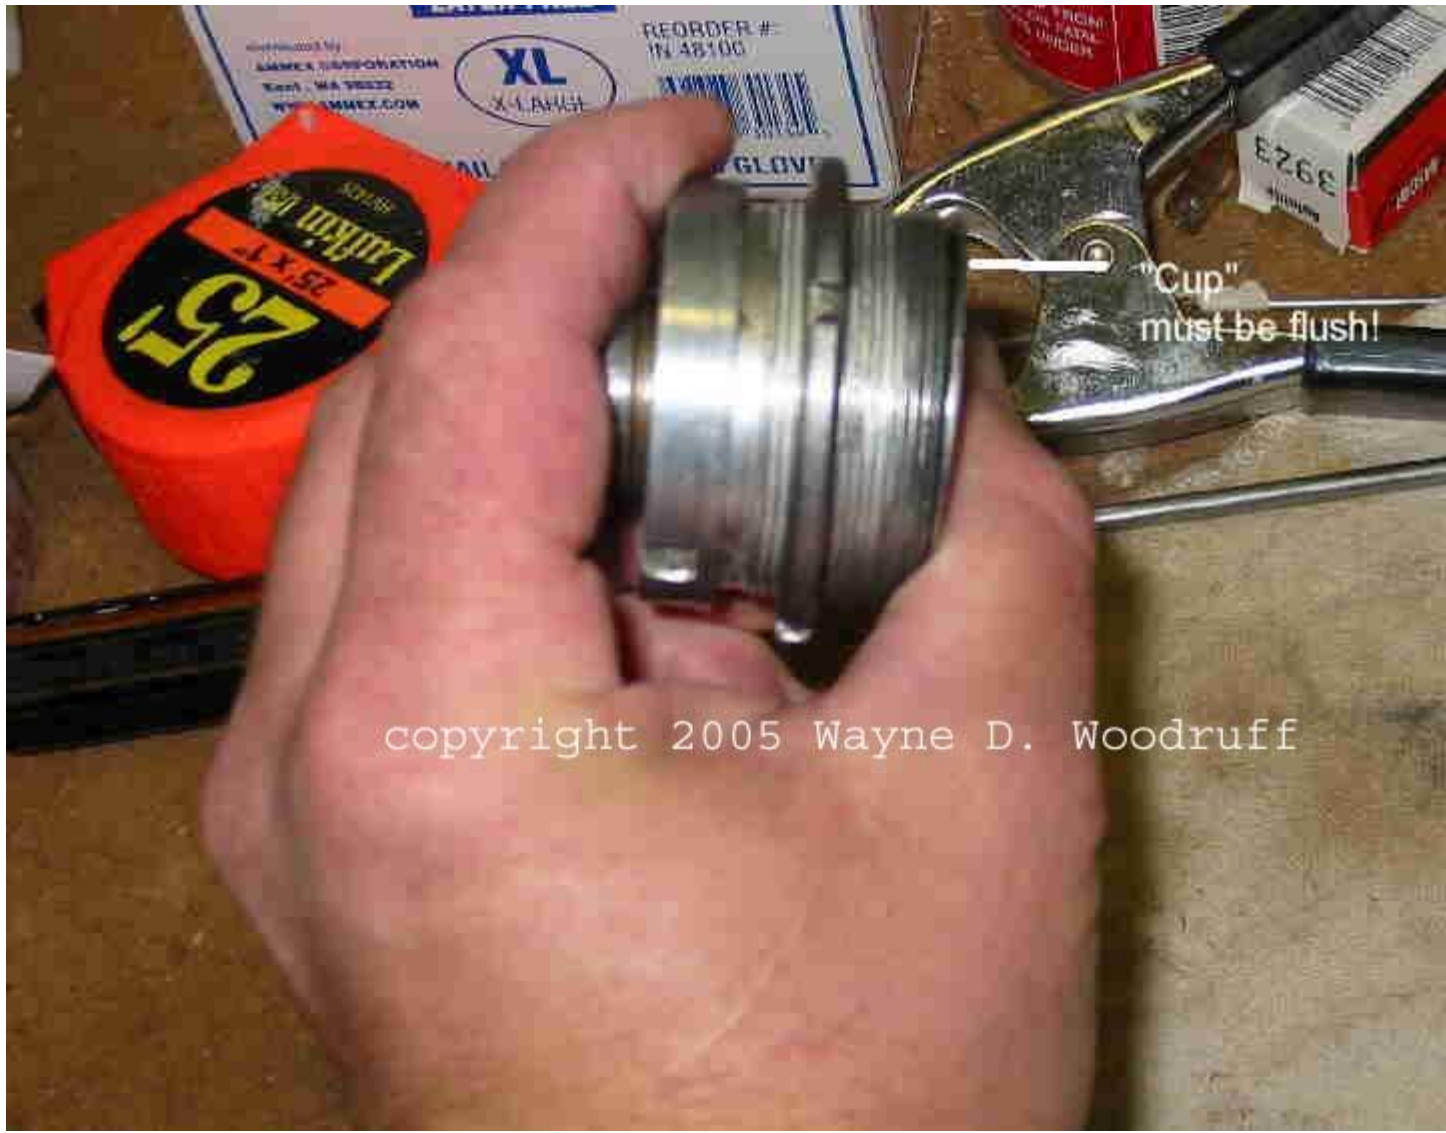
Fig 7: Side view of Fig 6 - showing cup MUST BE FLUSH with housing!

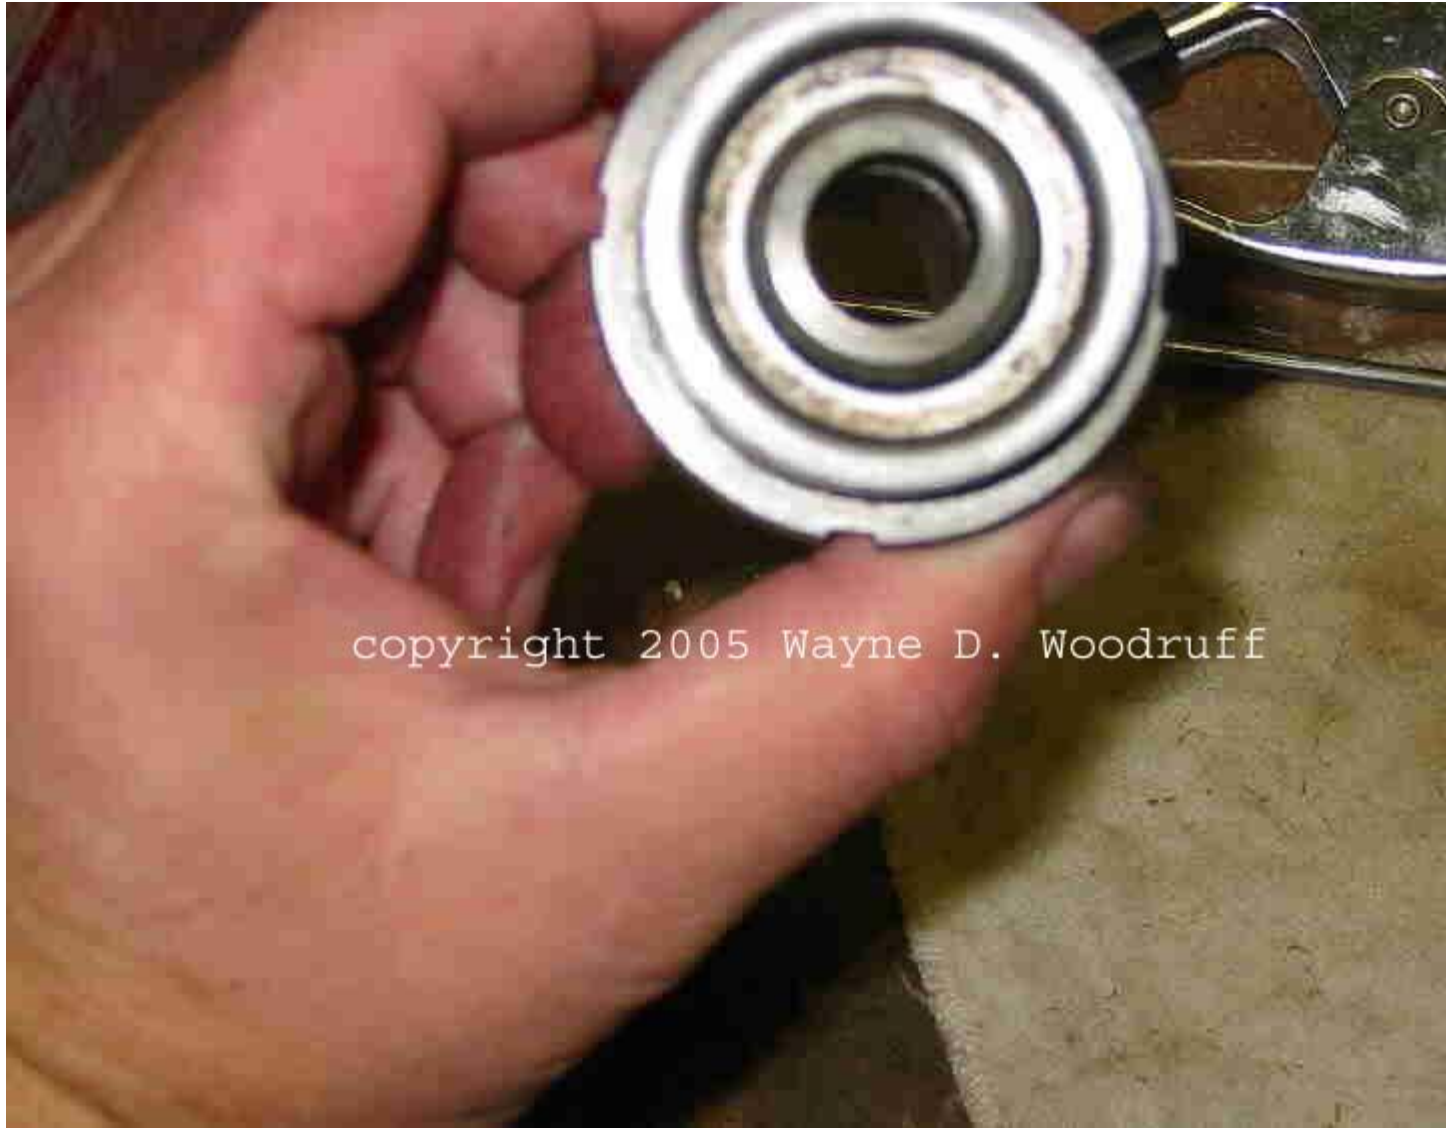
Fig 8: Added spacer (left-most item from photo #1)

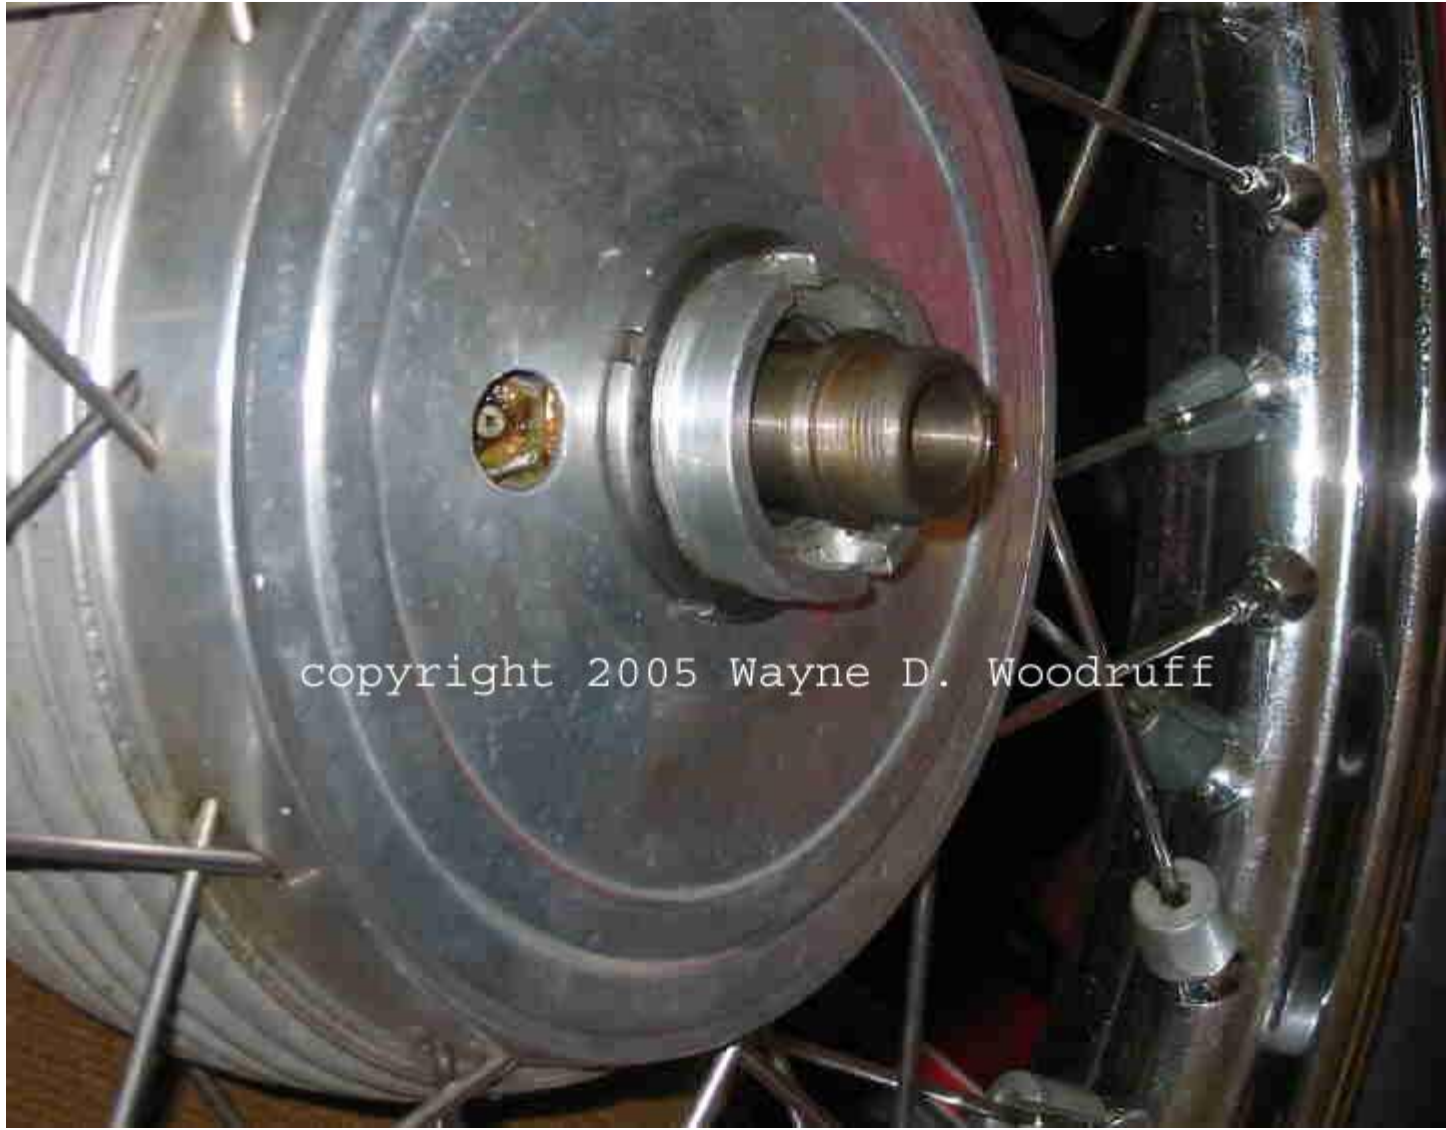
Fig 9: Adjusting nut installed in hub and locking ring tightened. NOTE ... I USED LOCTITE RED ON THE LOCKING RING. I had lots of problems keeping this ring locked without it

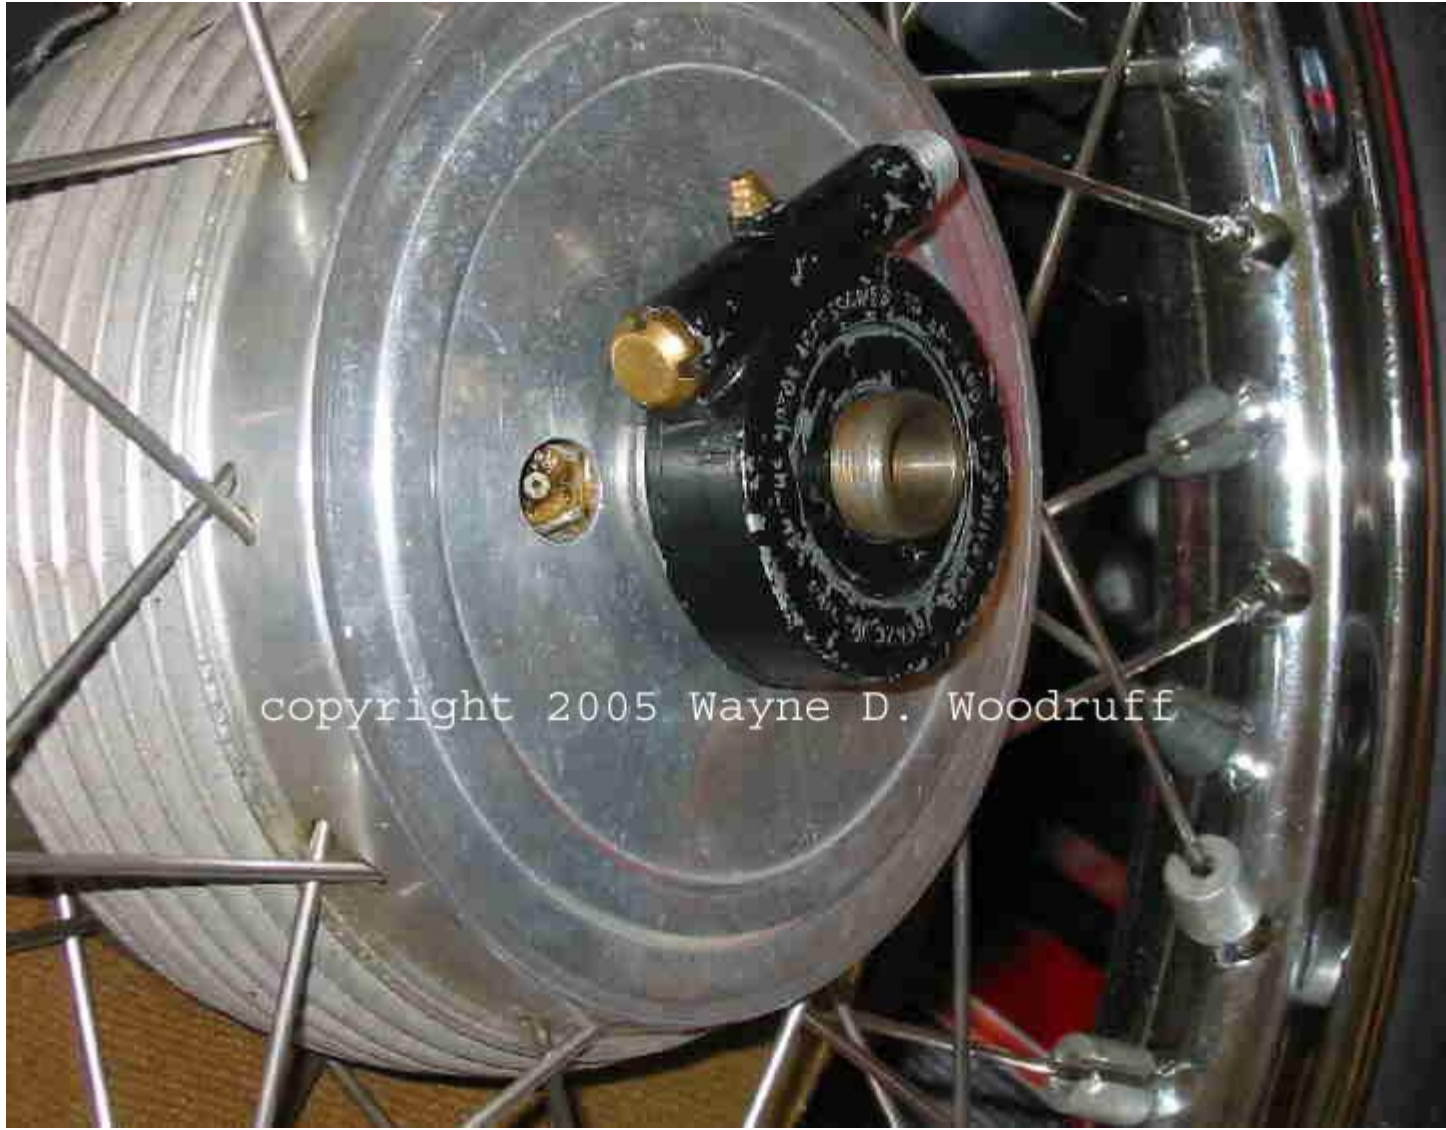
Fig 10: Speedo drive installed

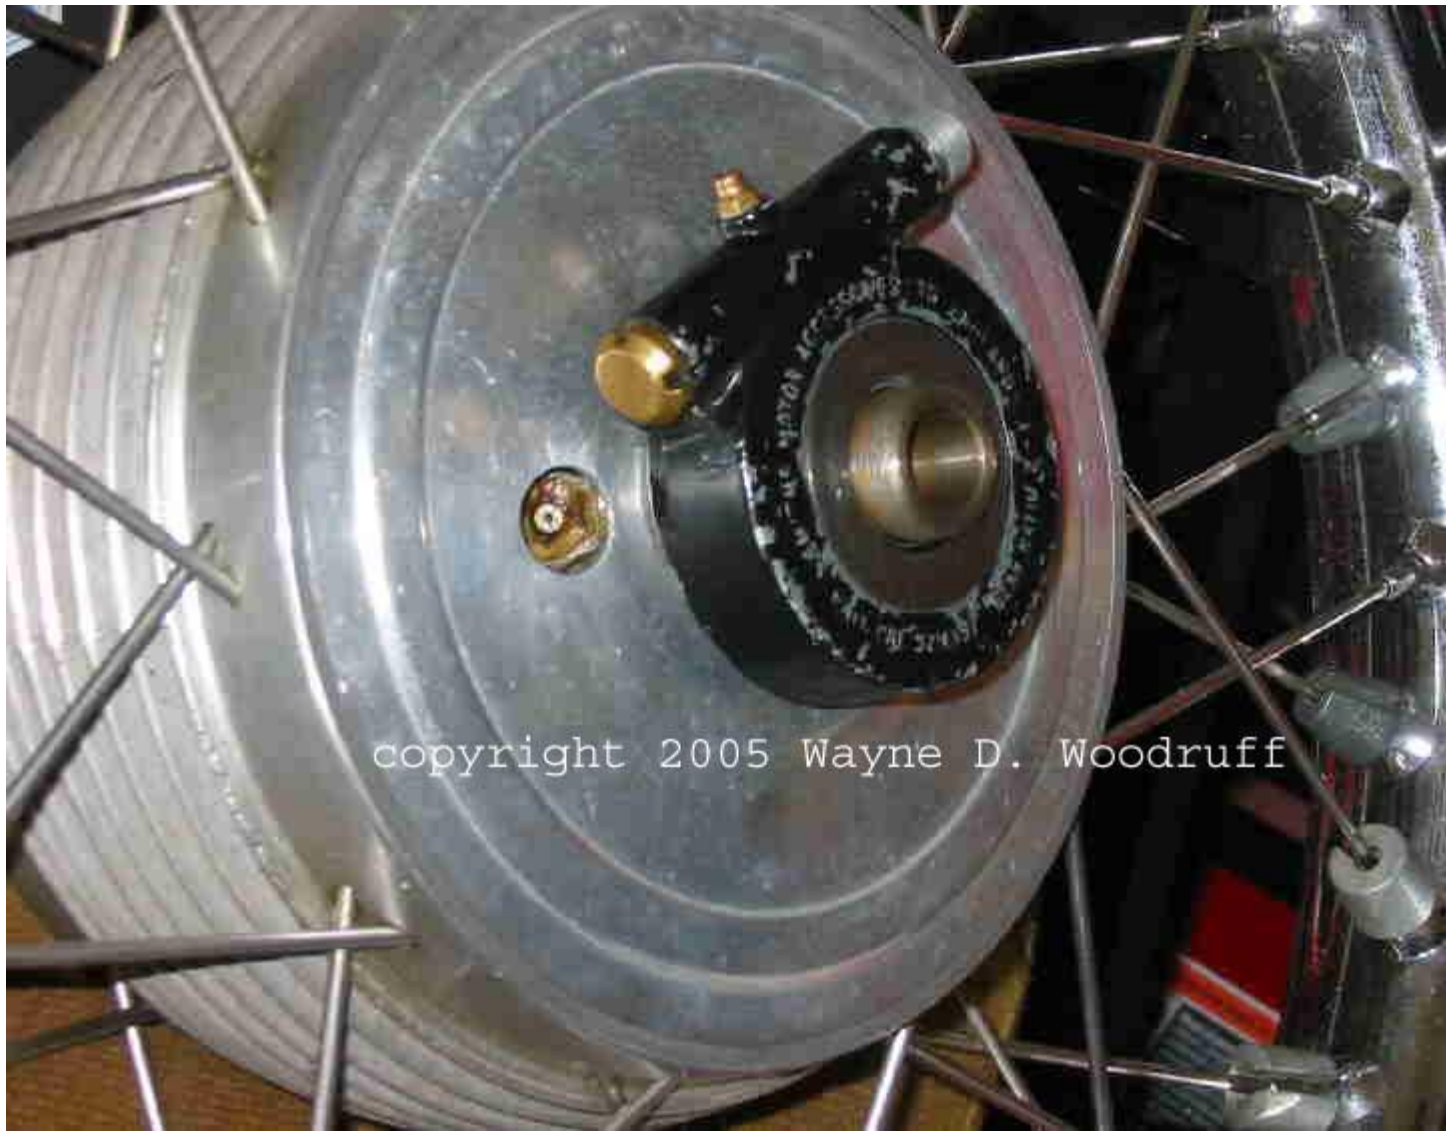
Fig 11: Speedo drive installed with washer

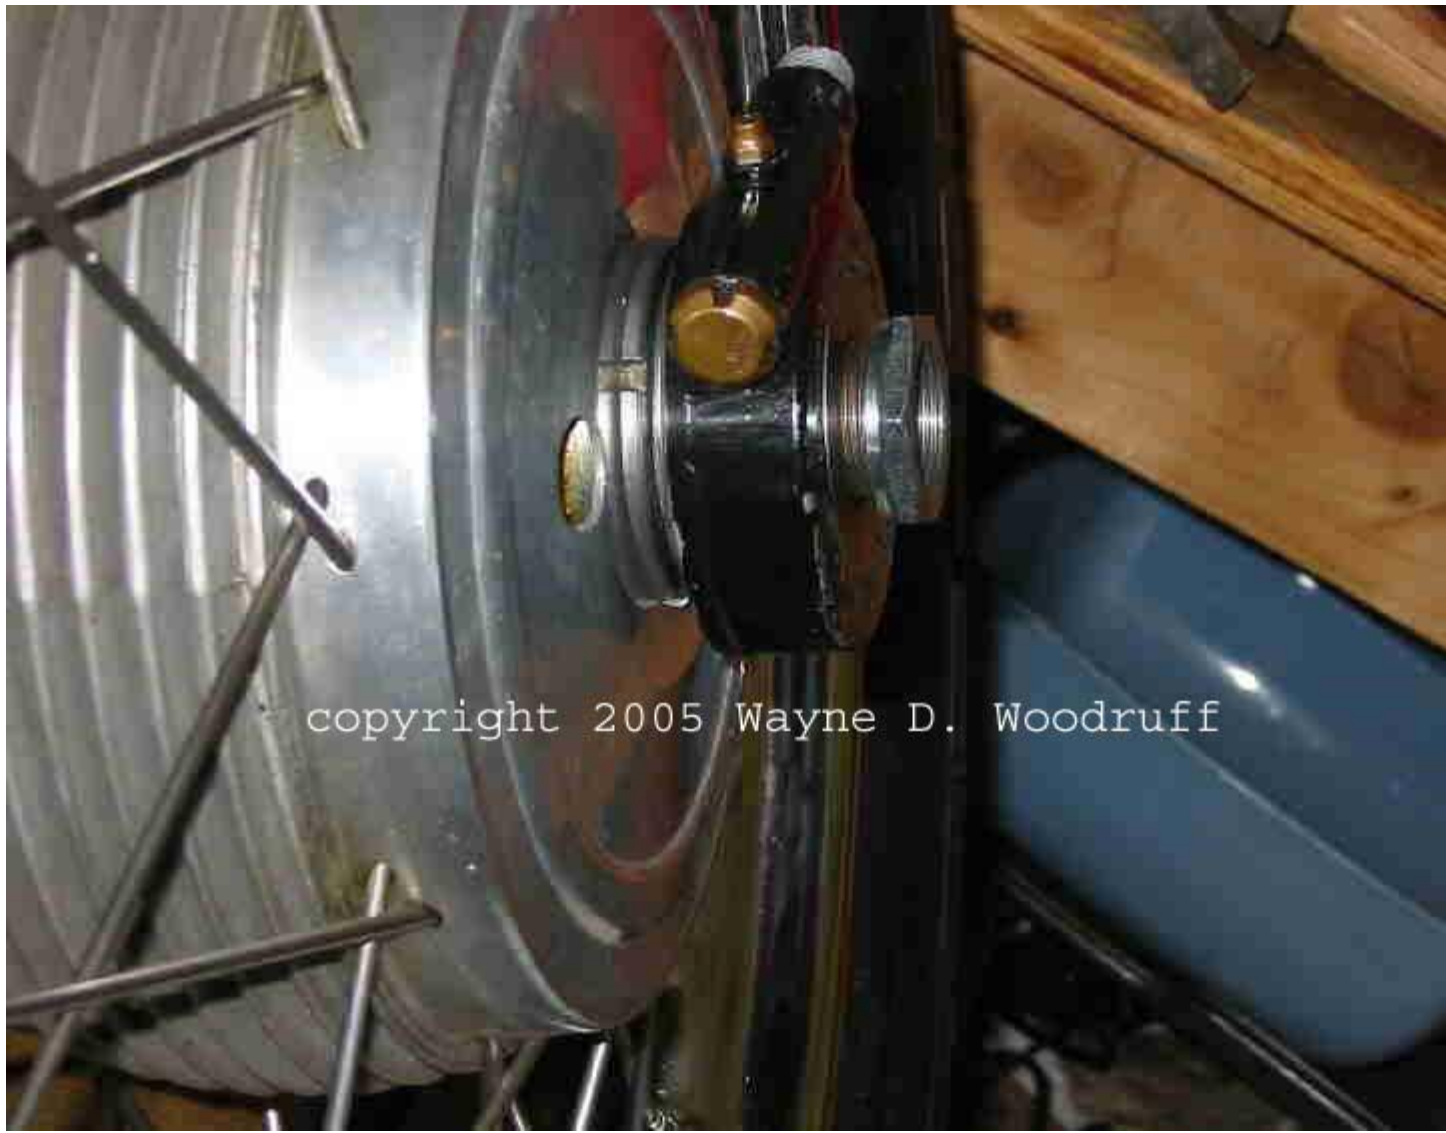
Fig 12: Speedo drive installed with washer and nut - note orientation of nut! The final tightening of the nut can be done with the wheel in place

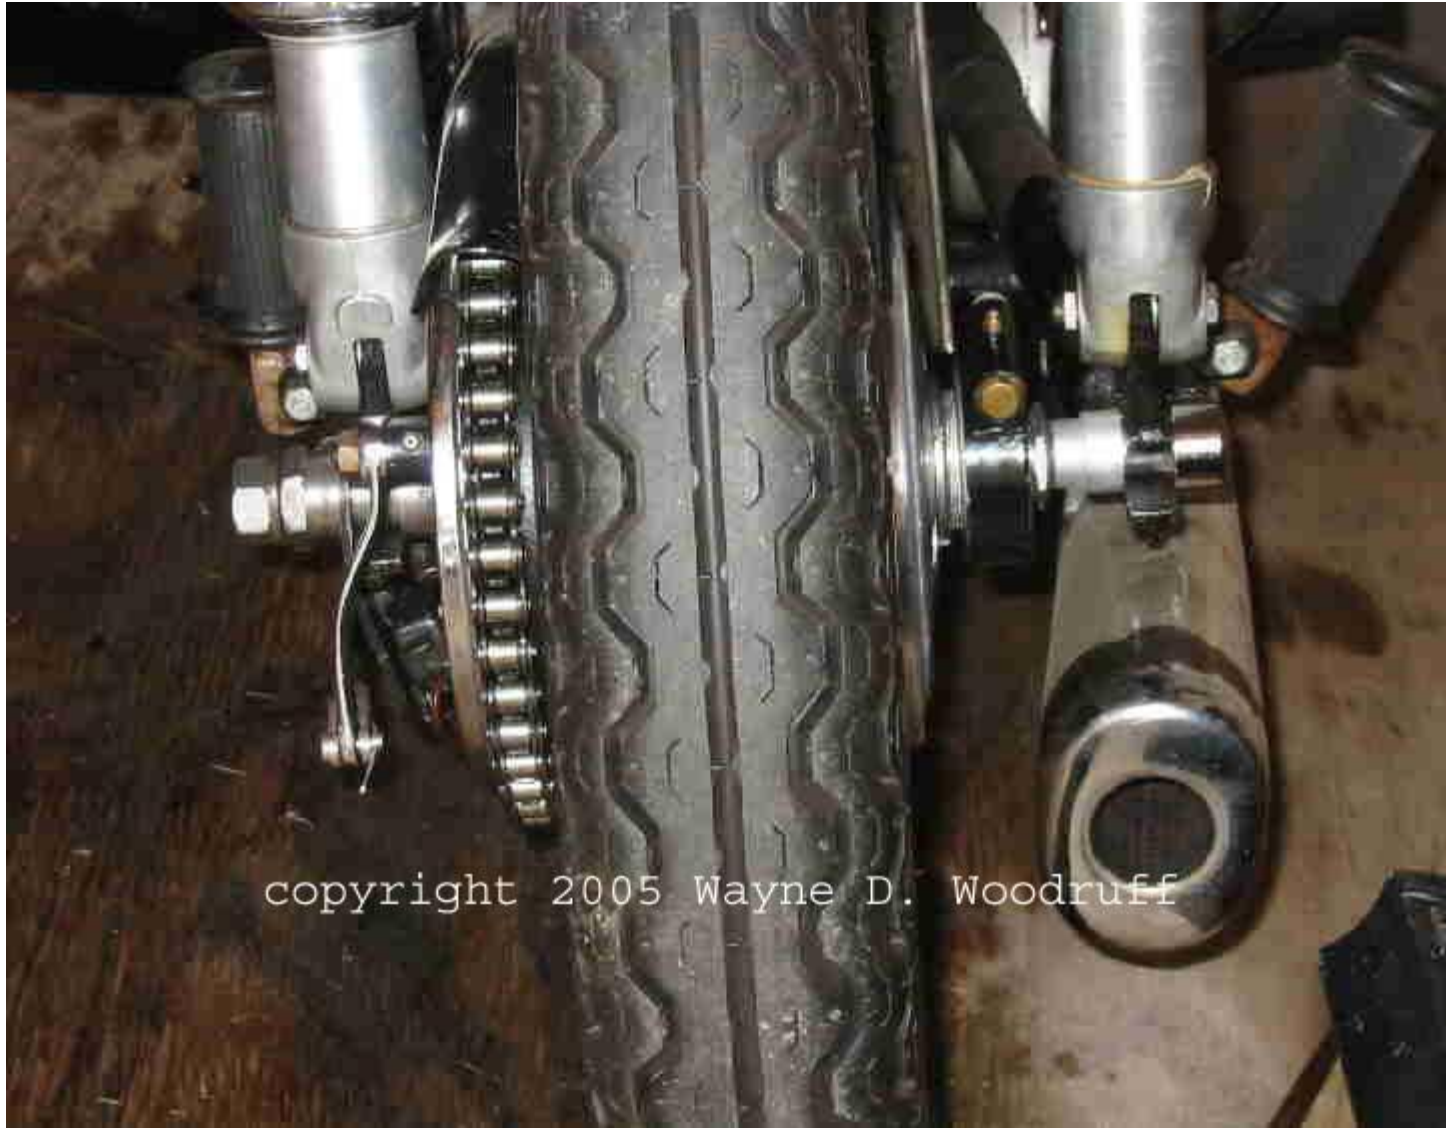
Fig 13: Right side of rear wheel showing all installed components
