AJS/Matchless Heavyweight Rear Hub, speedometer side assembly sequence

Assembly of the Speedometer side of the rear hub of a '56 G-11. This was done with assistance of the Jampot Article from January 1998 titled "The Heavyweight Rear Hub" by C.G., edited by Chris Read as well as moral support from Mark Siebert and Pete "the cheap". Since I had difficulties in getting mine assembled correctly, I thought I'd take the time to make a web page out of it for others to share.

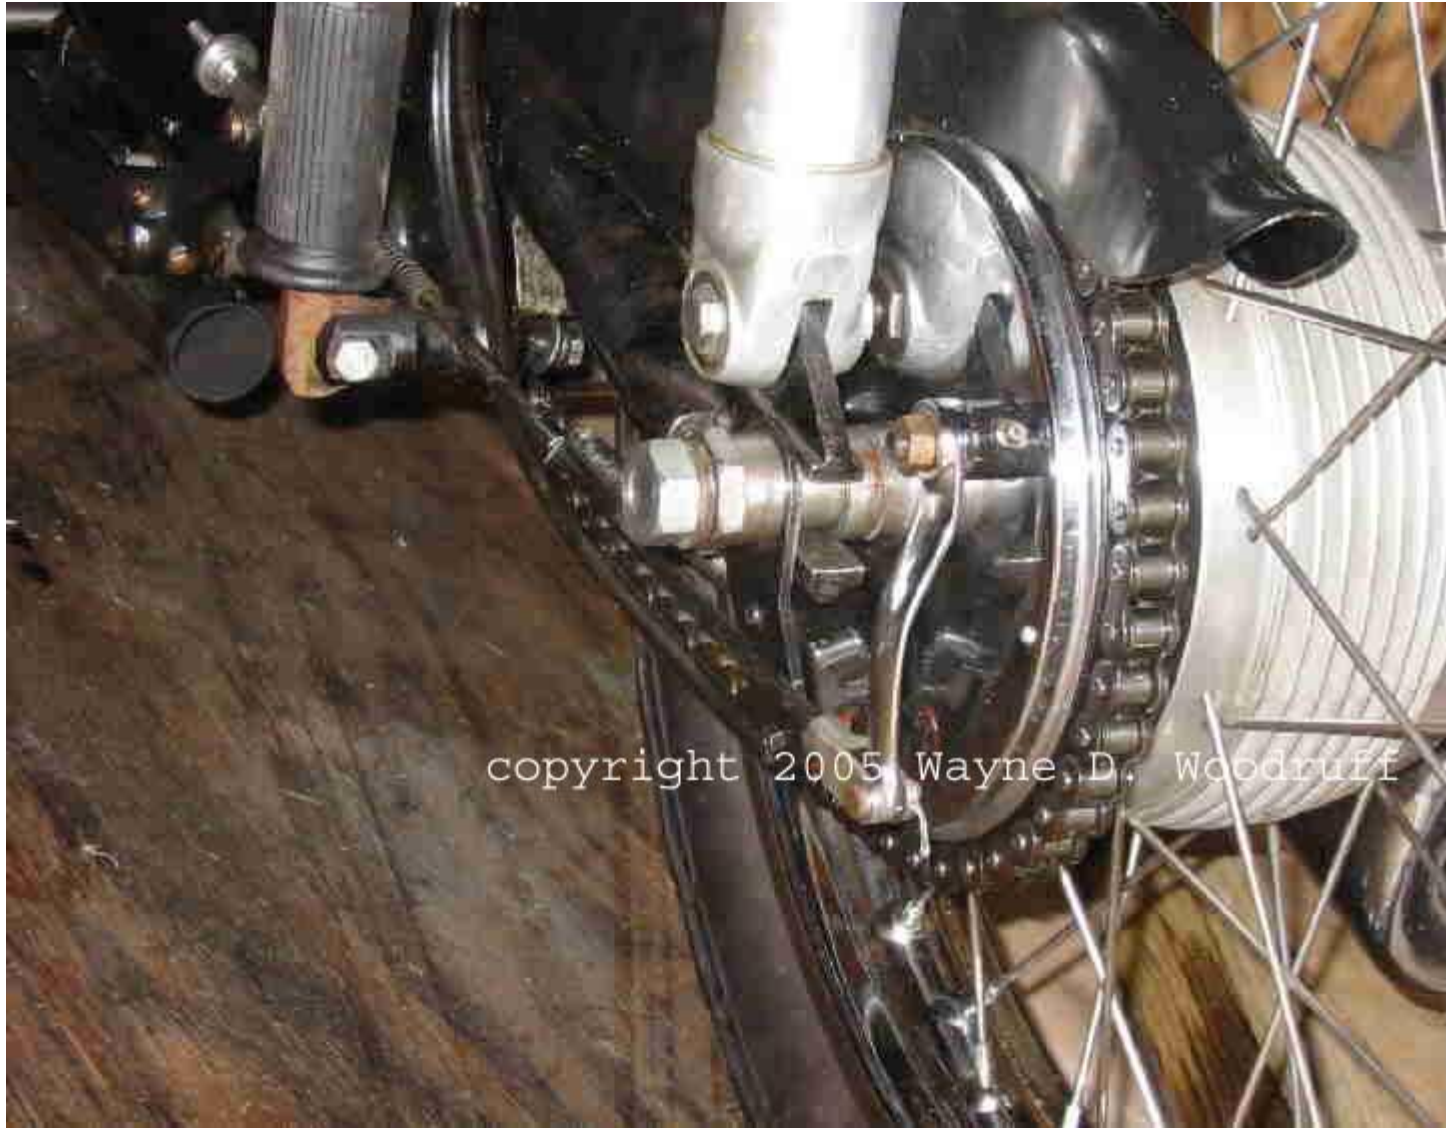
Fig 14: Left side of rear wheel showing all installed components
